# Hydrogen embrittlement

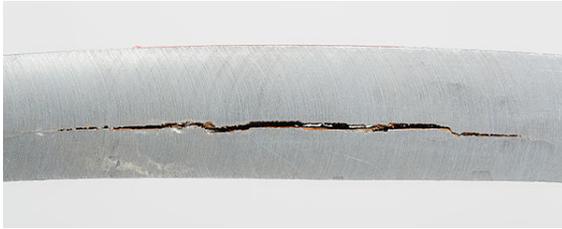
*Hydrogen Induced Cracks (HIC)*
